REF. No: LED19-32 1 of 3

SERVICE BULLETIN

SUBJECT: FIRMWARE UPGRADE TO TECO TELEVISION RECEIVERS VIA USB DEVICE
APPLICABLE MODELS: LED19JHRDHU, LED24JFRDHU, LED32JHRDHU

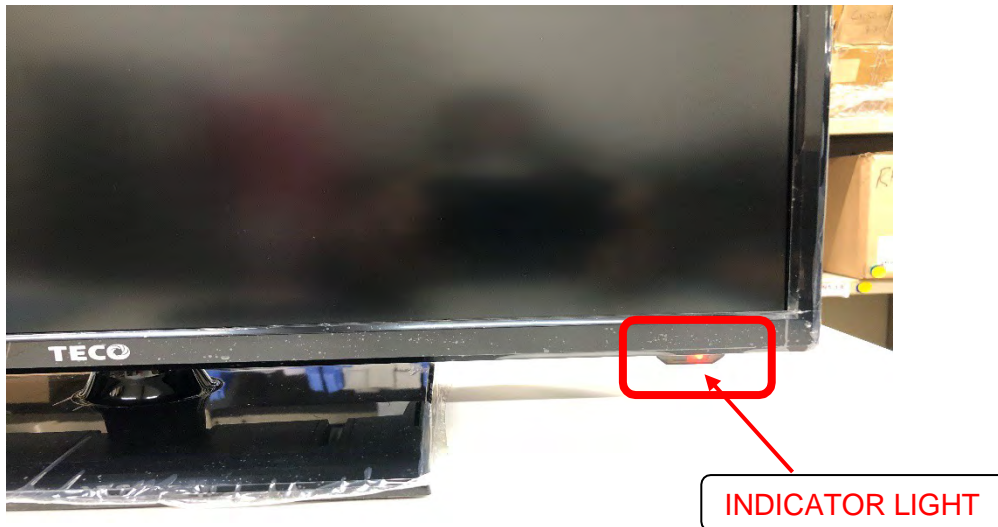
- The indicator light flashes alternately red and green (slow flash) during the upgrade process. The TV screen will not be lit up and no upgrade progress bar is displayed, as shown in the figure below:

- On completion of the upgrade, the indicator light will flash alternately red and green (quick flash), then disconnect the power, unplug the USB device, wait for the indicator light to go out and then re-plug the power supply adapter. The firmware upgrade is complete. (Upgrade time is about 20 seconds)
